Cathedral of Milan: Structural History of the Load-Bearing System

The structure of the Cathedral of Milan is studied. The features of the building and the original aspects of its load-bearing system are discussed. The progressive development of the structural system is described following its historical phases through four centuries. The final configuration is then analyzed with its main load paths. Detailed information, collected during the 20th century restoration work, was used to determine the geometry and loads. Preliminary analyses are based on equilibrium principles, within the framework of limit analysis for masonry constructions. The main structural restoration works taking place during the life of the Cathedral of Milan are outlined. The results provide a basis for the verification of more detailed numerical analyses and a reference for restoration interventions. Furthermore, the introductory analyses presented here develop the knowledge for future studies devoted to the Cathedral of Milan, encompassing structural, construction, and architectural issues.

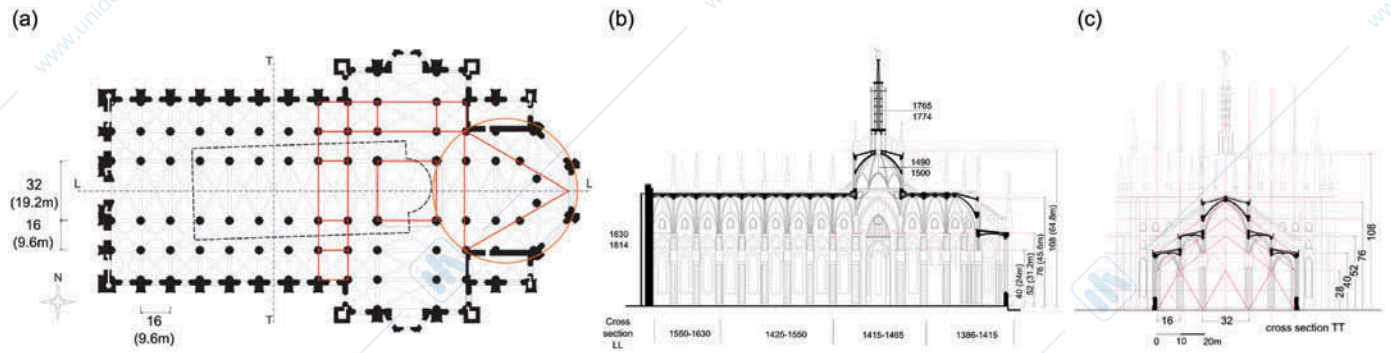
FIG. 1. Geometry: (a) plan (broken line: position of the previous Basilica of Santa Maria Maggiore); (b) longitudinal and (c) transverse sections. (Units are Milanese *braccia* = 0.6m; square module in plan of 16 *braccia* = 9.6m).

accommodating the inclination of the stone roof. The dome of the tiburio and the vaults of the apse have similar systems of double vaults, as can be seen in Figures 1b-c and described in the following Section 3.

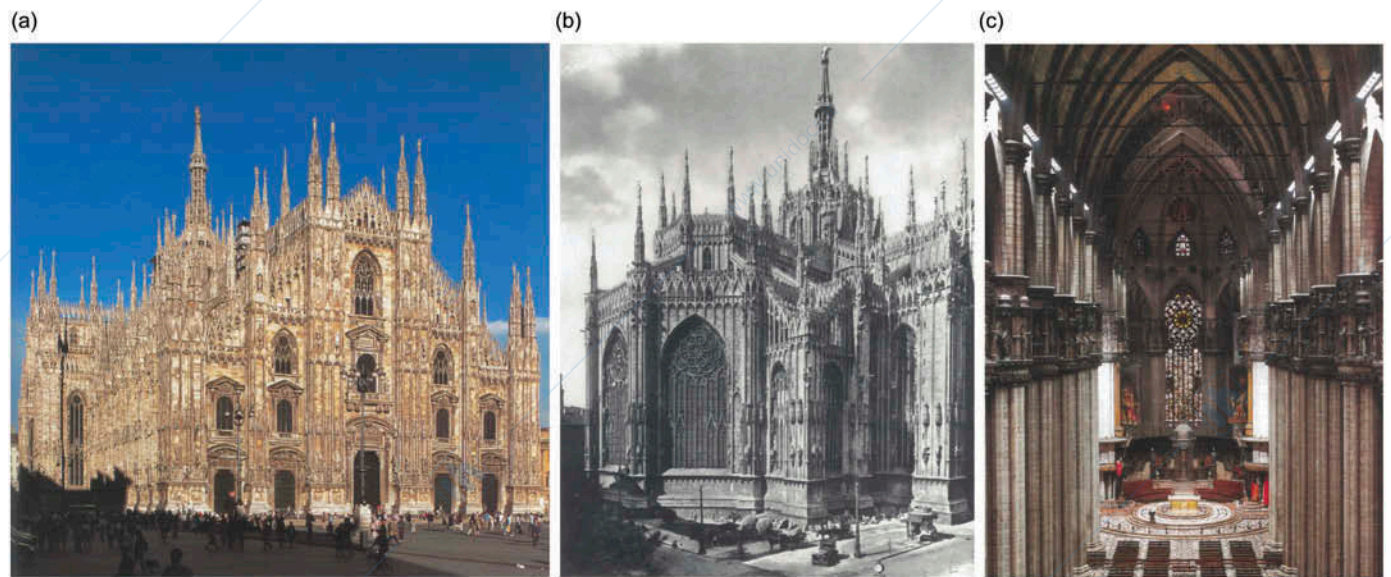
FIG. 2. Perspective views: (a) northwest; (b) northeast; (c) interior, main nave looking from west to east.

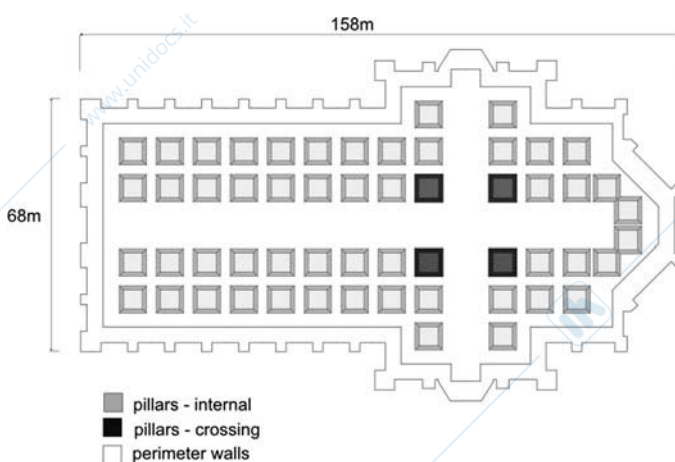
FIG. 3. Foundations.

The perimeter foundations are continuous walls (Figure 3) made of *serizzo*—a metamorphic stone typical of the Southern Alps, reaching down to 7 m below the floor of the church, with 1m visible above ground on the exterior. The foundations under the piers take the form of truncated pyramids made of brick, reaching to 7 m below the floor of the church, where the water table was at the time of construction.

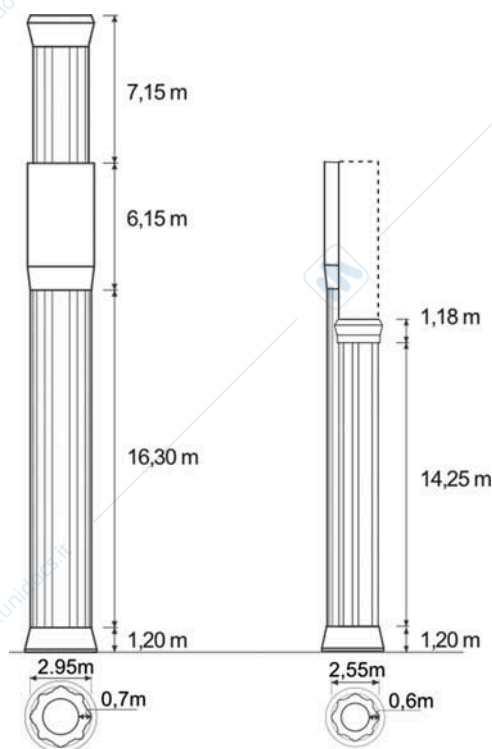
FIG. 4. Pier configuration and cross-section: (a) piers of the crossing supporting the Tiburio (vertical dimensions valid for all piers of the central nave, with diameter 2.55 m); (b) lateral piers between the side naves.

The interior piers all have the same cross-section (Figure 4), inscribed in a circle with an outer diameter of approximately four *braccia* (2.55 m as built), with the exception of the four main piers of the crossing with an outer diameter of four and three quarters *braccia* (2.95 m as built). The intention at the beginning of the construction was to provide the same cross-section for all piers, including the four main piers of the crossing, meant to support the tiburio with the dome and main spire. A larger cross-section for these four members was proposed by Matteo da Campione in 1390, at the time master

All longitudinal and transverse arches are pointed (Figure 4), made of Candoglia marble. The same cross section was used for all such members in the naves: the width is 1.05 m; for the depth, these members are made of Candoglia voussoirs approximately 0.5 m deep, above which brick walls have been built. The geometry of these walls is explained more in detail in the following. The pointed arches along the four sides of the crossing have greater depth, equal to 1.3 m. Iron tension ties were provided for all arches in the building from the beginning of the construction.

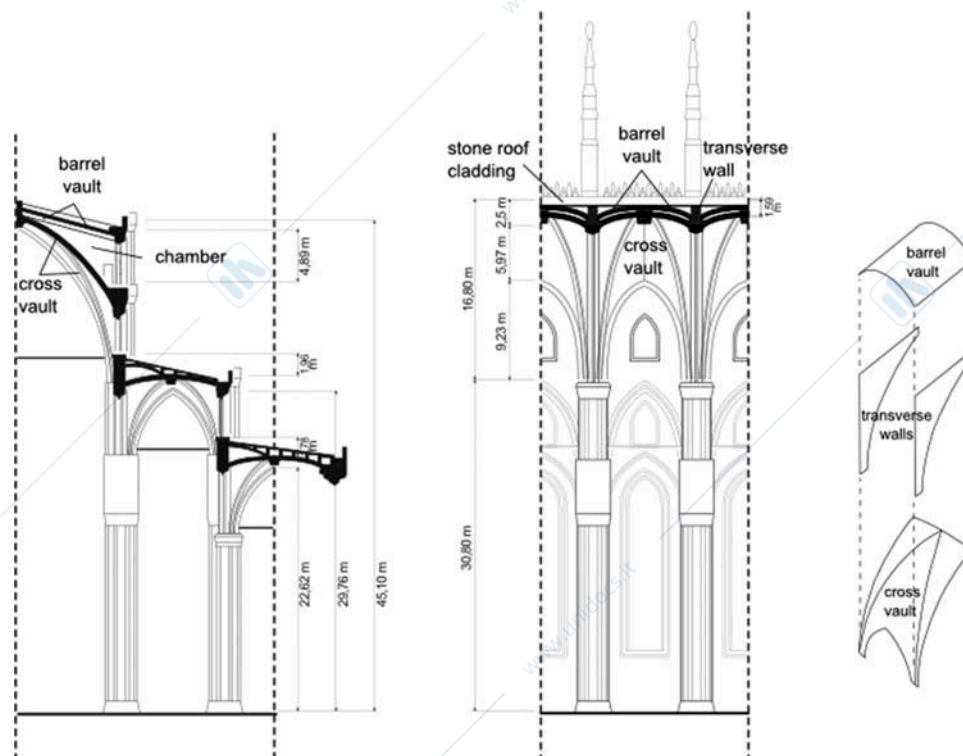
FIG. 5. Double vaults of the naves (drawn without flying buttresses, as shown in Figure 6): (a) transverse cross-section; (b) longitudinal cross-section; (c) scheme of the double vaults.

The vaulting system of the central nave is made of double vaults (Figure 5), superimposed at two different levels in elevation, one covering the interior of the church and the other above supporting the stone roof. Figure 5a shows that also each side nave has a double brick shell, in the half towards the interior,

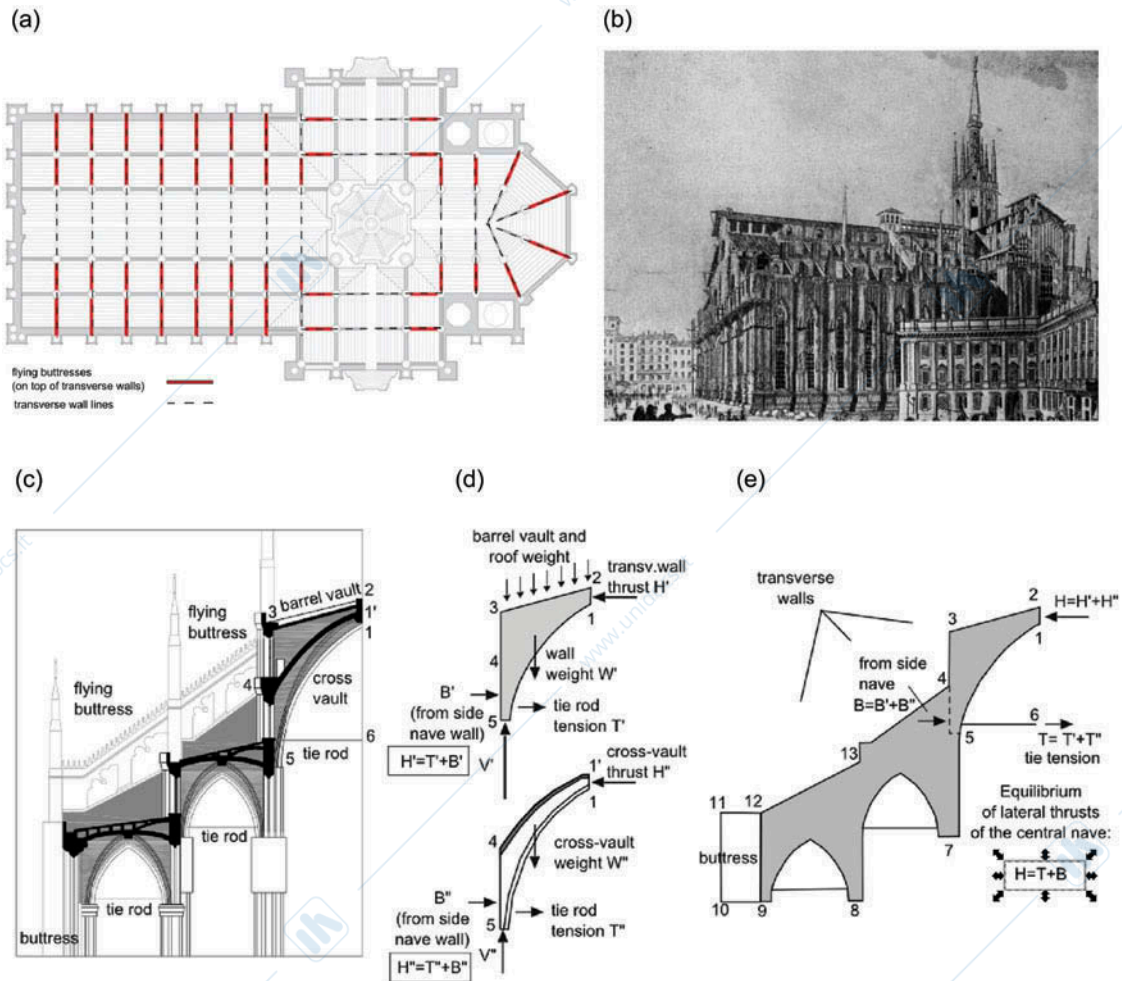
FIG. 6. Transverse walls and flying buttresses: (a) position in plan; (b) historical drawing by Gallari (1808); (c) configuration in the cross-section; (d) equilibrium of transverse walls with barrel vaults and cross vaults; (e) transverse walls and ties to balance the thrust of the central nave.

The weight of the upper barrel vaults increases the resultant of vertical loads, with respect to that of a timber roof— frequently used to cover the vaults in many similar buildings. Ferrari da Passano (1988) stated that the load increase due to the barrel vaults makes the resultant forces at the support on the piers more vertical, in the sum with the horizontal thrust of the quadripartite vaults. This would, according to this author of this article, reduce the cross-section necessary for the piers, reduce the tension of the ties of the arches and eliminate the need of flying buttresses. Moreover Ferrari da Passano (1988) and Beltrami (1881–1914 [1964]) underline that the flying buttresses of the Cathedral are not necessary for the structural stability. Their position in fact (Figure 6c) is high above the points where the lateral thrusts act. Archive researches suggest and Bradford Smith (1997) amongst others reports that they were added in the 19th century, as confirmed by historical drawings (Figure 6b).

The shape and position of the transverse walls supporting the barrel vaults must be considered (Figure 6a-b). The intrados has the shape of the transverse pointed arches of the nave, and the extrados the inclination of the roof (Figure 6c-d, points 1-5). These walls develop arch action, transferring their self-weight and that of the barrel vaults to the supports above the piers (Figure 6d, point 5) with both a vertical component and a horizontal thrust. Simple equilibrium calculations based on the load resultant indicate that these vertical and horizontal forces

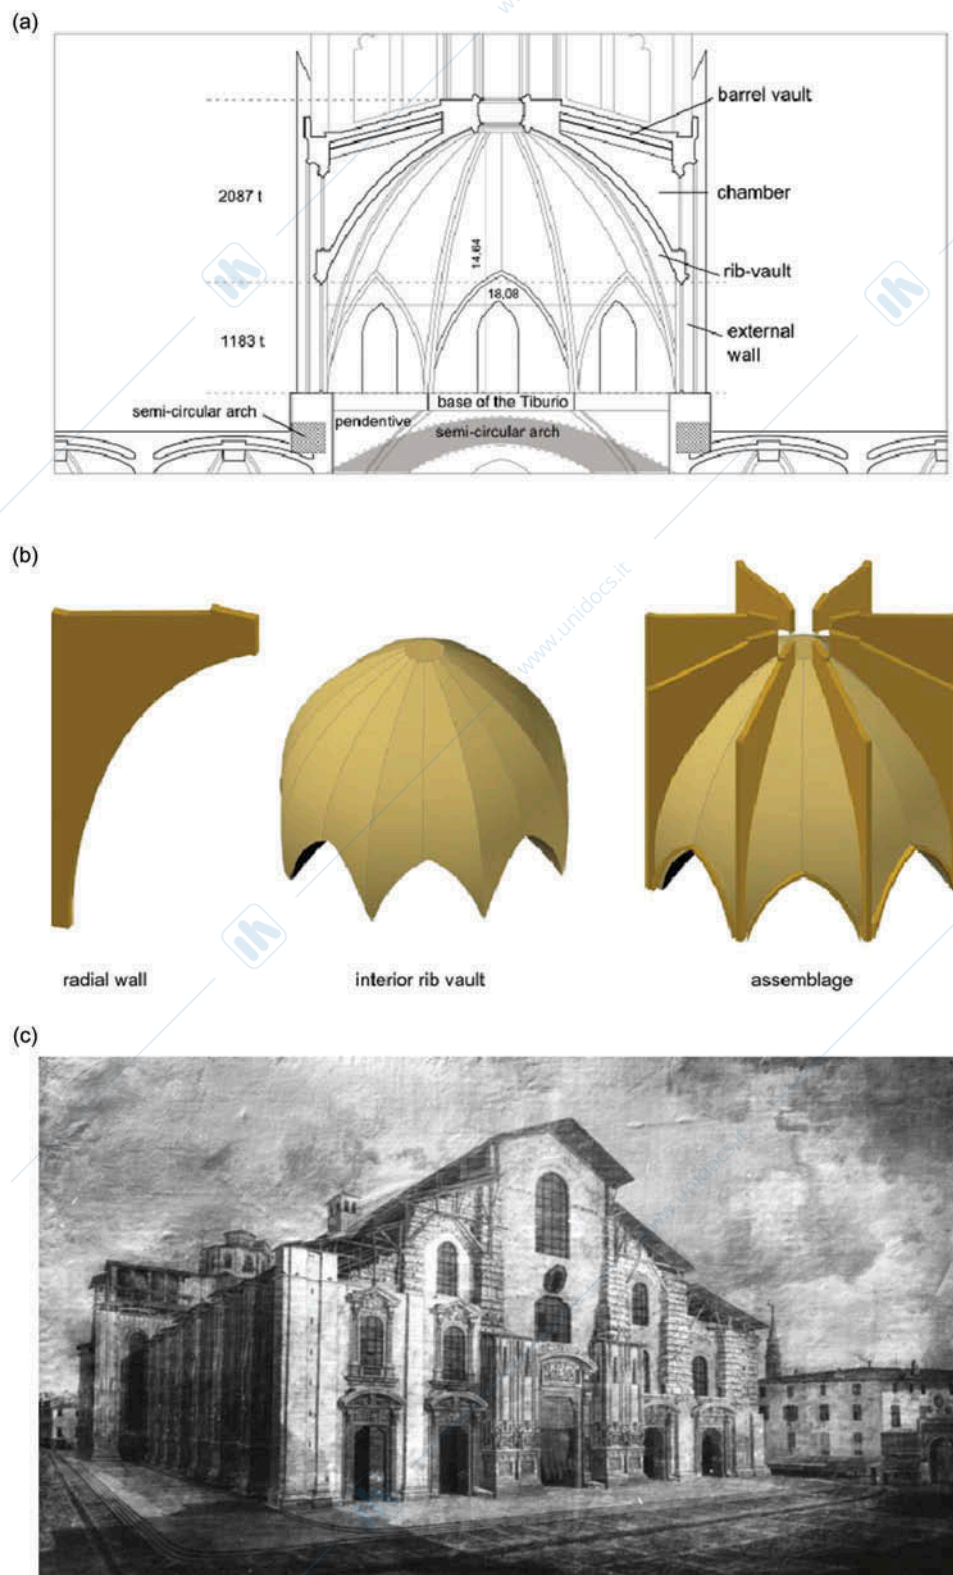
FIG. 8. Tiburio: (a) geometry and weights of the lower and upper part (divided by horizontal broken lines); (b) three-dimensional representation of radial walls and interior vaults; (c) historical drawing by Dal Re (1735).

The radial brick walls support the barrel vaults at the top (Figure 8b), the roof and the main spire with the flying buttresses. Moving from the interior to the exterior the load distribution on each of the walls (Figure 11a) includes two forces at 2.0 m distance for the weight of the spire; the weight of the brick barrel vaults with 0.4 m thickness, the stone floor of the roof, the flying buttresses, and the self-weight of the walls. At the outer end, at the base of the dome, the last contribution is the weight of the vertical walls enclosing the eight sides of the tiburio, with one spire on the top of each.

Regarding the interior vaults, the ribs are visible on the interior surface of the dome (Figure 8a). The rib cross section has the same shape of those of the vaults of the naves, with a depth of approximately 0.5 m. The dome vaults (Figure 8b) are made of brick with 0,4m thickness in the top part, from the ring at the top to the crown of the window arches, at 6.5 m from the base of the tiburio; close to the supports the volume between the outer wall of the tiburio and the inner vault is filled with brick. The load path is analyzed by equilibrium of meridian and circumferential forces balancing the gravity loads (Huerta 2003; Como 2013) for a portion of one eighth of the vault, from the crown of the dome to the level of the crown of windows. This model is used, as recent surveys carried out by the Veneranda Fabbrica del Duomo did not highlight any cracking. It is assumed that

the weight of the marble ring at the crown is carried by this system (Figure 8). Results are shown in Figure 11b; the circumferential forces pass from tension to compression at a level corresponding approximately to the crown of the windows. Here the builders placed circumferential iron tension ties. It is interesting to note that for this part of the construction it was also possible to find an equilibrium solution with radial arches, under the classical hypothesis for limit analysis of masonry of no-tension resistant material (Heyman 1967).

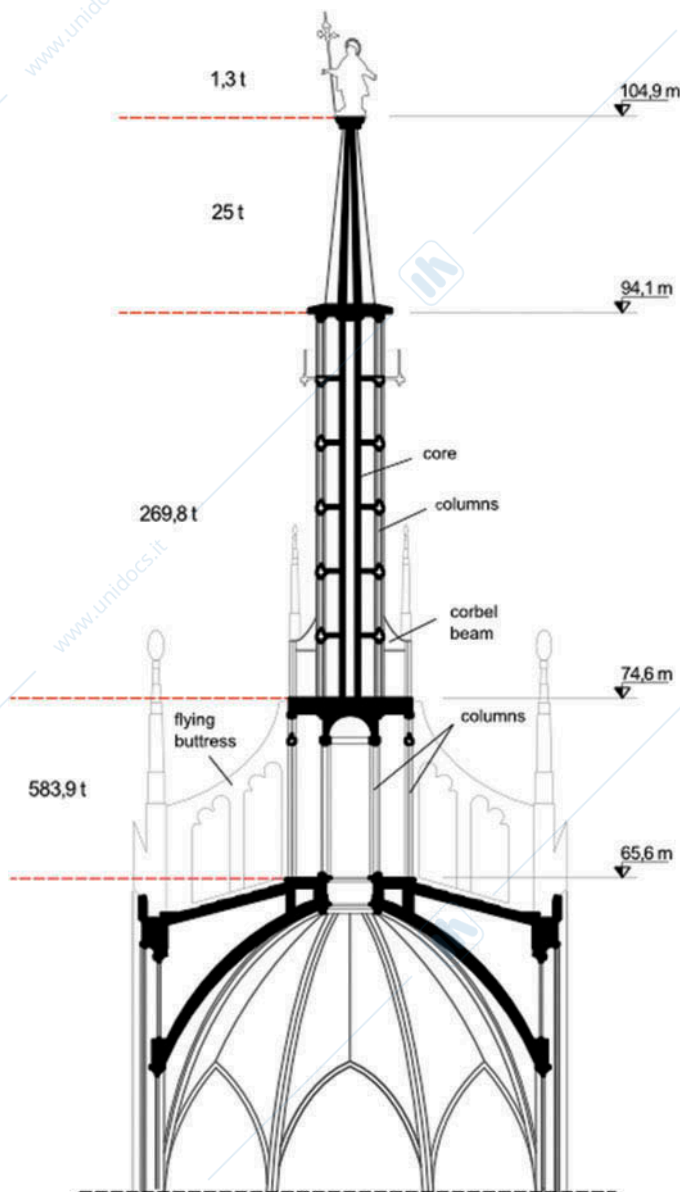
FIG. 9. Main spire geometry and weights of parts (divided by horizontal broken lines).

As already mentioned the structure of the spire is composed of an inner cylinder and eight outer piers on an octagonal base (Figure 9), above the level of 74.6 m. At this level the scheme changes partially, in correspondence of a horizontal terrace. A few meters above, horizontal corbel beams widen the width of the structure, and, below these beams, the outer piers double in two vertical elements at each vertex of the octagon; thus the whole structure is stiffened. Hence these vertical elements transfer 16 reaction forces on the crown of the dome, arranged in two circles, one at the inner and the other at the outer radius of the ring, with a distance of approximately 2 m. This influences the load path in the underlying dome. To determine the equilibrium force distribution at the base of the spire the weight is simply divided into 16 equal forces—equal reactions in the inner and outer ring of supports.

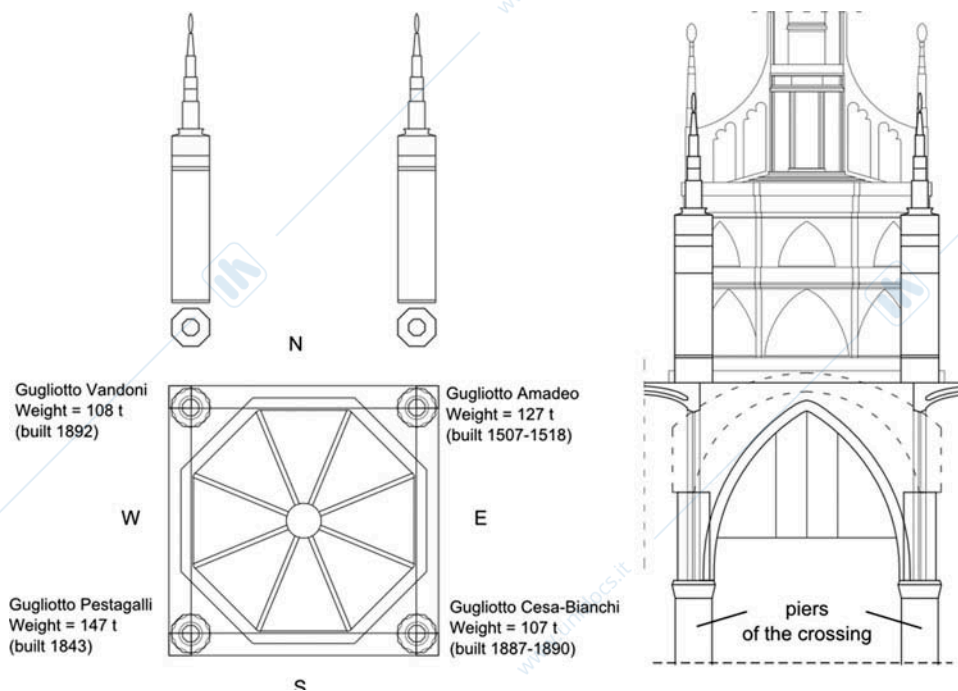
FIG. 10. Position of the *gugliotti*, weight, load transfer onto the piers of the tiburio.

The four *gugliotti* (Figure 10) are small towers with spires at the top, placed on the roof at the four corners of the square corresponding to the perimeter of the crossing. The first was built between 1507 and 1518 by Amadeo above the north-east pier and the others followed much later in the second half of the 19th century, named after their builders: Pestagalli (1844–1847); Vandoni (1892); Cesa Bianchi (1887–1890). Their position corresponds to the piers of the crossing, and their load flows directly onto these members. The weight of each *gugliotto* is reported in Figure 10. The overall axial force of each pier increases with the weight of the corresponding *gugliotto*. The contribution of 100–150 tons given by each is less than 5% of the total axial load, approximately equal to 3000 tons at the base of each pier. Nevertheless significant damage showed in these vertical members with cracking of the outer Candoglia ring. Historical reports show that this led to the closing of the Cathedral at the end of the 19th century for restoration works. The event is highly important, showing that these members were already close to their safety limit at the time.

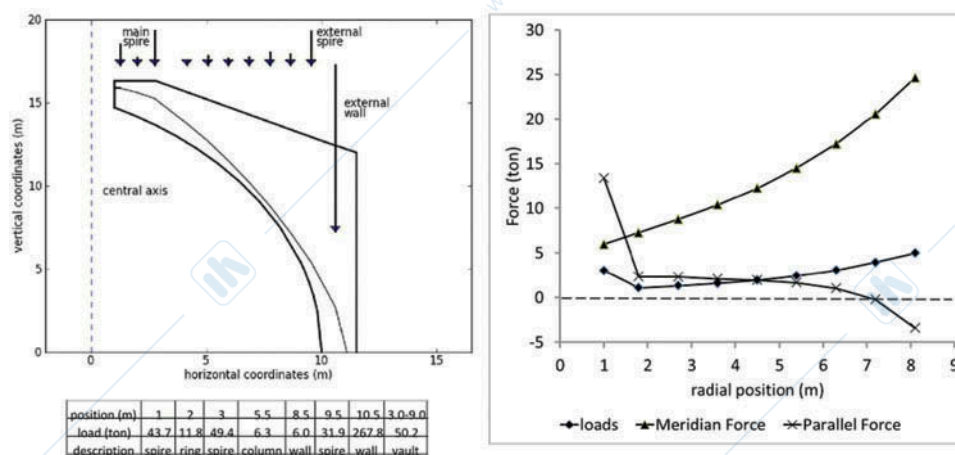
FIG. 11. Dome: (a) loads and thrust lines for the radial walls and (b) loads and membrane forces of the interior vaults.

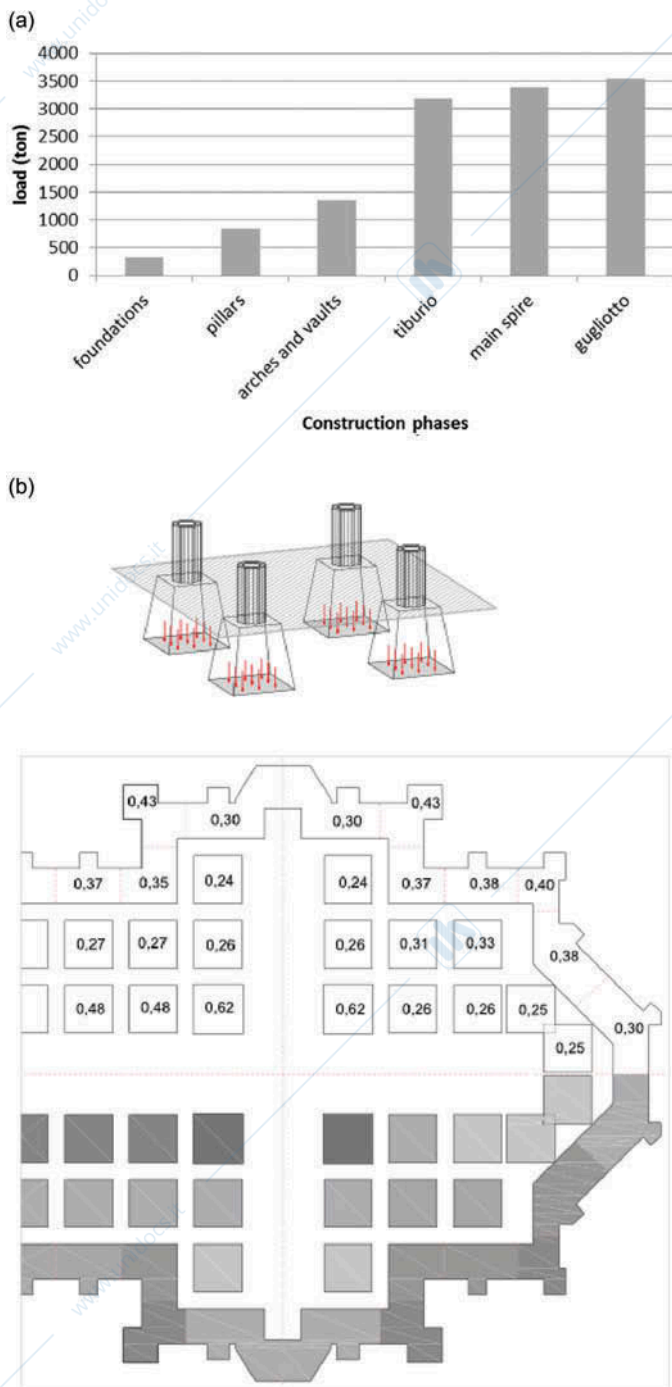
FIG. 13. Foundations: (a) evolution of loads in time under the main piers (level -7m); (b) pressure (MPa) under the foundations (7 m × 7 m) of the piers in different positions in the final state (shades of gray indicate intensity qualitatively).

Forces at the base of the foundations of the main piers have been calculated in the different phases of the history (Figure 13a). This diagram shows that the most important load on these members was the construction of the tiburio. It can be stated that already at the construction of the tiburio around year 1500 the safety margin was relatively low, considered that these members were bearing nearly 3000 tons and showed significant damage at 3500 tons. Nominal stresses under the foundations of piers in different positions of the plan have been calculated, assuming square foundations with a dimension of 7 m (Figure 13b).
